## PROJECT REPRESENTATIVE'S DAILY REPORT

Pg. 1  
Report No. 056  
Date: 2014-11-05  
Day: Wednesday

**Project:** Renovation and Addition to Tewksbury Town Hall

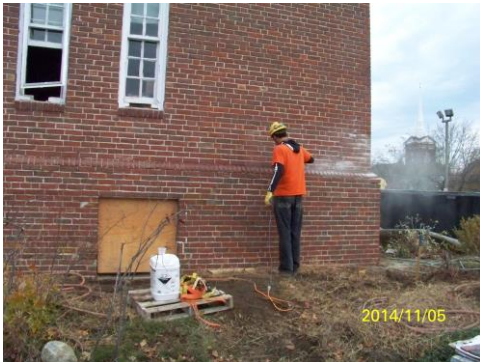
Photo showing mason cutting out joints on the south elevation of the south wing.

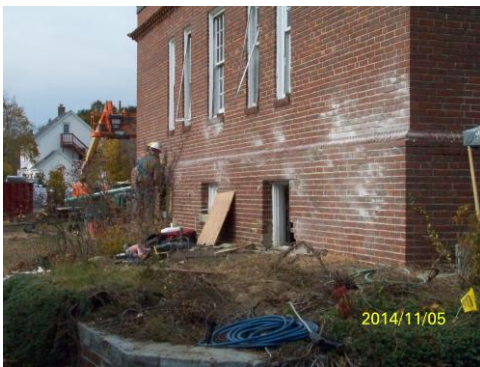
Photo showing masons working together to cut out the joints and keep the dust down.

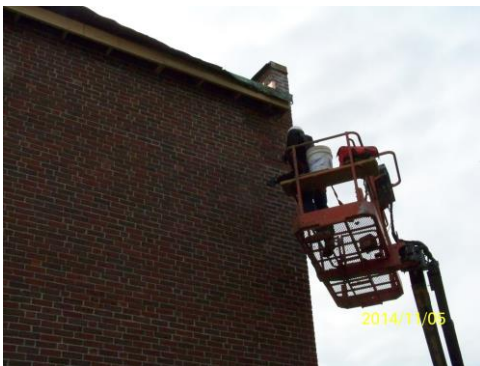
Photo showing mason pointing the northwest corner of the meeting hall.

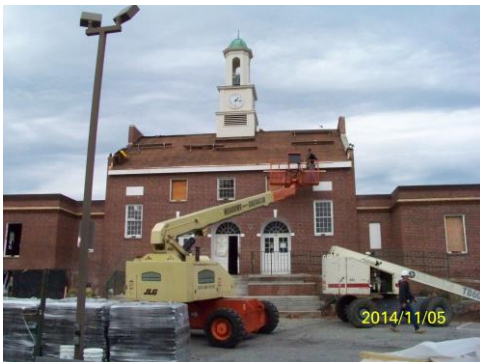
Phot showing roofer installing the copper drip edge.

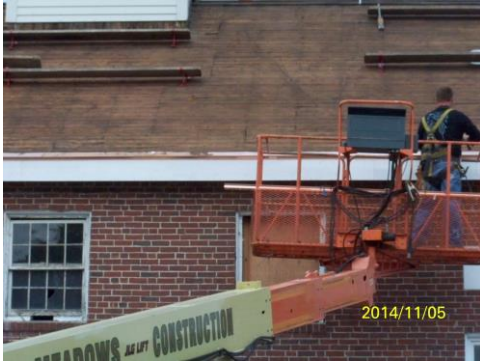
Close-up of the roofer installing the drip edge.

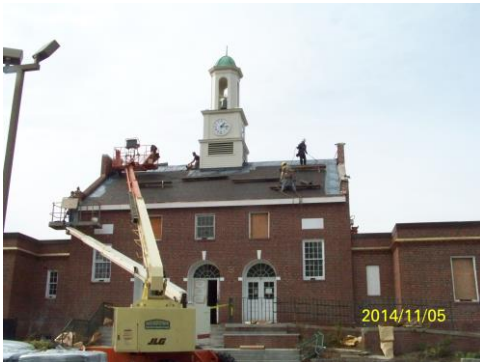
Photo showing the roofing underlayment being installed.

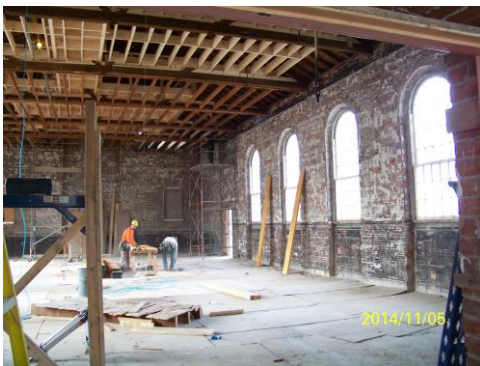
Photo showing carpenters ready to install the framing around the perimeter of the meeting hall.

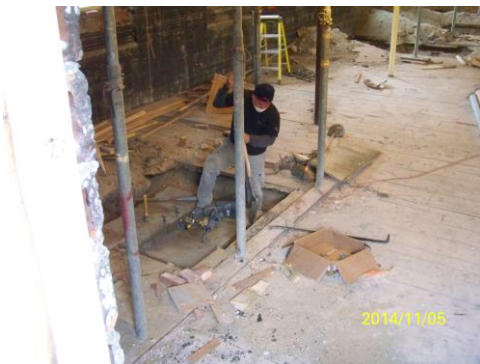
Photo showing the footing locations being backfilled.

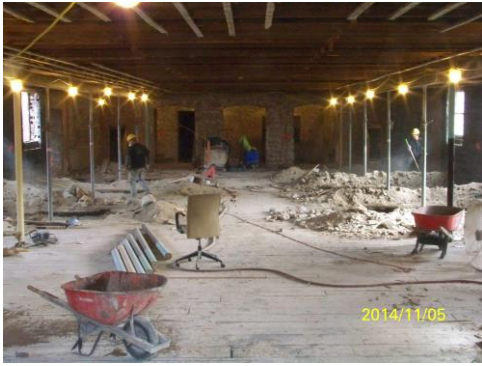
Photo showing the footing excavations being backfilled.

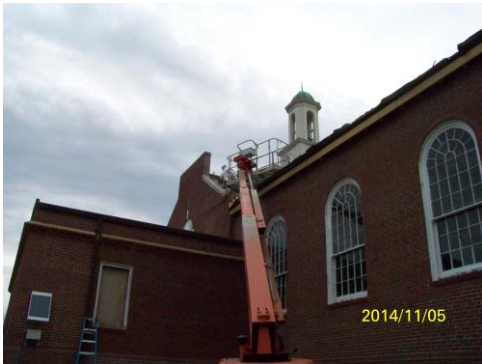
Photo showing the west side of the main roof being abated.

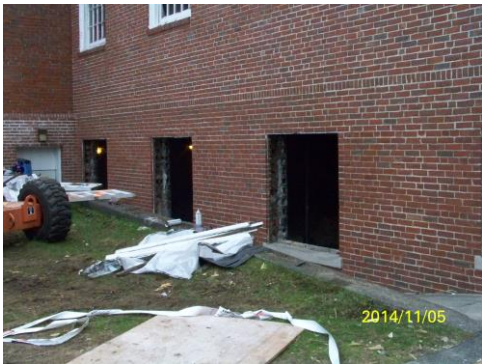
Photo showing basement windows on the north side of the meeting hall abated.
